**ST JAMES'S HOUSE
STRUCTURAL ROBUSTNESS
ASSESSMENT REPORT
BRIGHTON AND HOVE CITY COUNCIL**
October 2023

St James's House
High St, Kemptown
Brighton and Hove
BN2 1RW

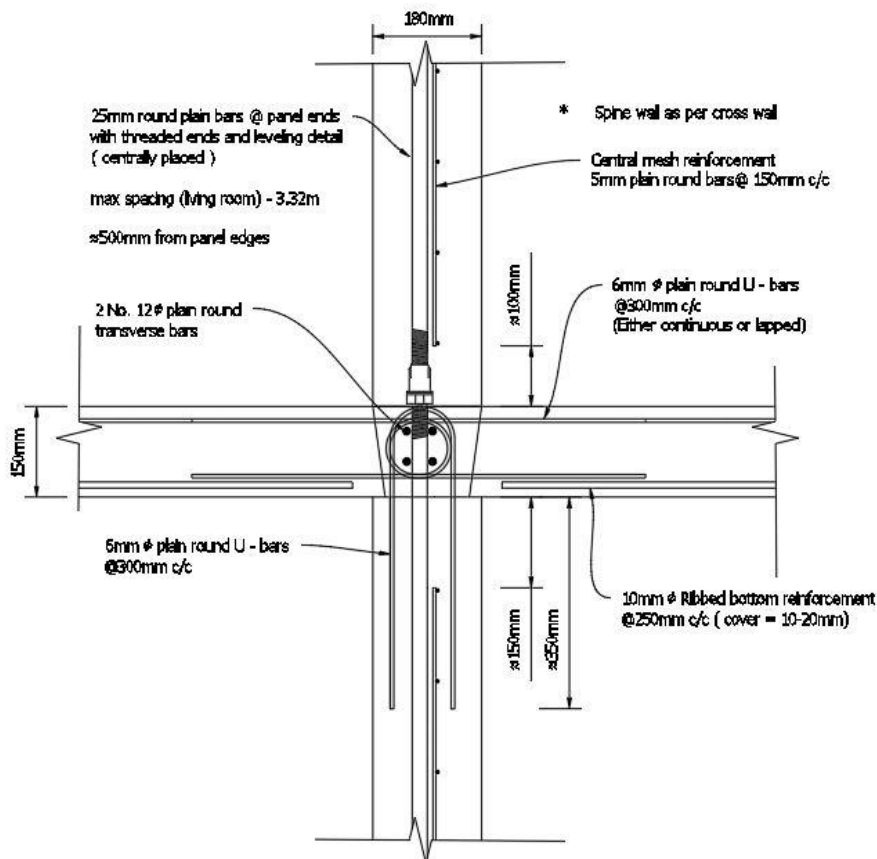
Figure 5 – Cross wall / floor slab detail

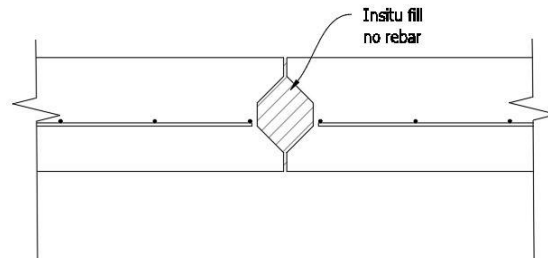
Figure 6 – Cross wall vertical joint

However, the U-bars protruding from each panel are in the other orientation and therefore do not connect 'loop around' the vertical lacer bar.

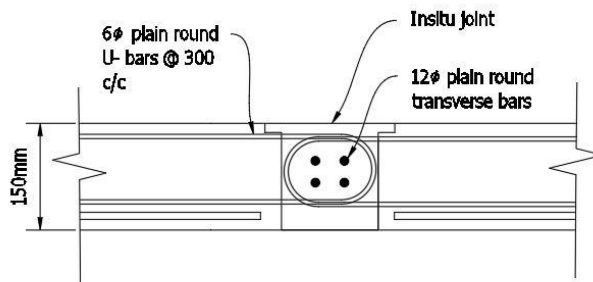
Figure 7 – Floor to floor joint in hallway (no cross wall present)

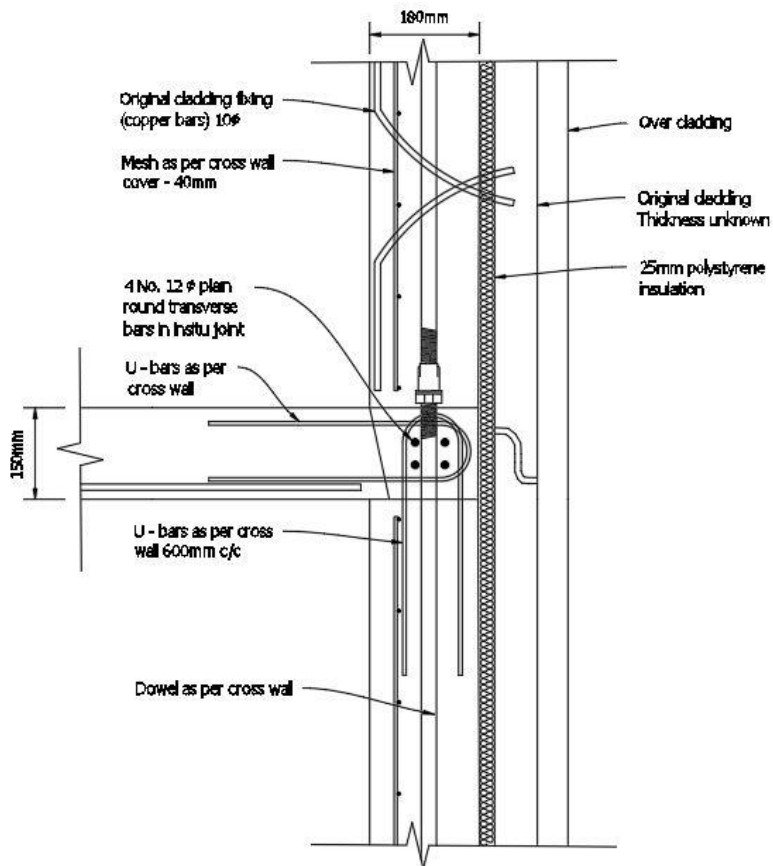
Figure 8 – Flank wall

- Flat 78
 - Compaction in flank wall joint is poor, the bars have surface corrosion due to voids.
 - Remedial ties were observed – 25 \emptyset ribbed bars inserted diagonally from the floor into wall joint. However, this was only found on flank and spine walk. There were no remedial ties cross walls and ceiling.
- Flat 99
 - Hallway floor to floor joint transverse bars densely packed. There are voids in concrete resulting to corrosion.
 - Flank wall joint is poorly compacted.
 - Very low concrete covers. The minimum recorded, 4mm. Surface corrosion were noted.
- Flat 16
 - Generally adequate.

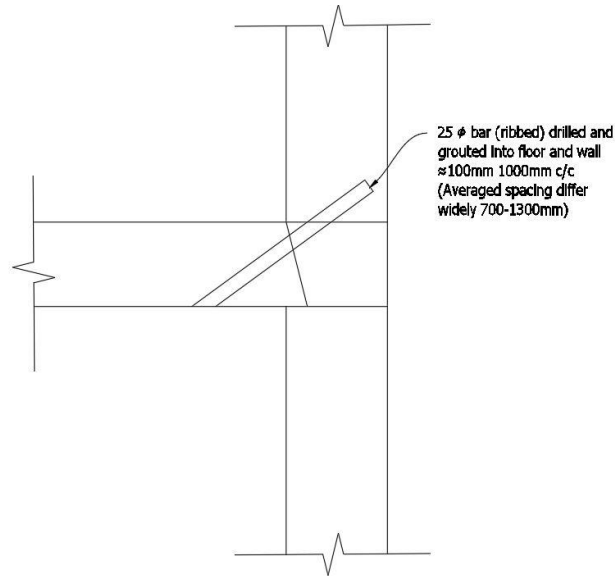
* The Flank Wall joints appear to have additional bars stitched in, potentially as a remedial measure. However, regardless, the block will not pass as the other joint types fail.

Figure 9 – Remedial ties for flank and spine walls (section)

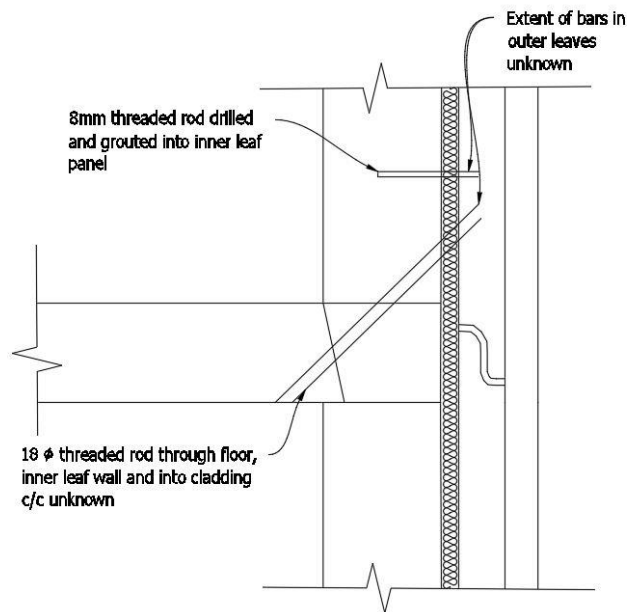
Figure 10 – Cladding ties flank wall section
