**ST JAMES'S HOUSE
STRUCTURAL ROBUSTNESS
ASSESSMENT REPORT
BRIGHTON AND HOVE CITY COUNCIL**
October 2023

St James's House
High St, Kemptown
Brighton and Hove
BN2 1RW

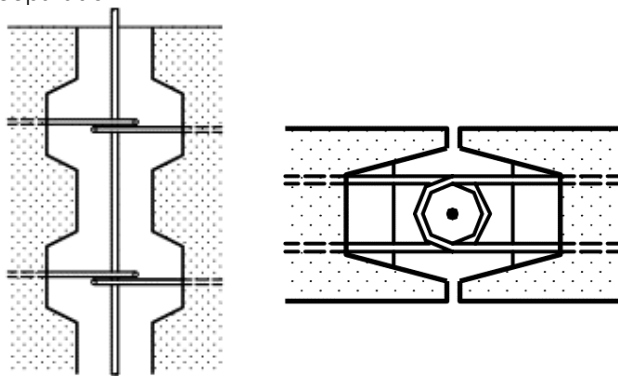
Figure 14 – Typical shear key connection at a vertical joint between wall panels (fib, 2008)

The longitudinal vertical joints between abutting wall panels is in the form of a 'shear key' connection. It would be expected that this type of joint would contain reinforcement, similar to that shown in Figure 14, to prevent the joint from uncontrolled separation.

However, the U-bars protruding from each panel are in the other orientation and therefore do not connect 'loop around' the vertical lacer bar.
