**NETTLETON COURT  
STRUCTURAL ROBUSTNESS  
PRELIMINARY EXECUTIVE SUMMARY  
REPORT  
BRIGHTON AND HOVE CITY COUNCIL  
June 2024**

## **NETTLETON COURT STRUCTURAL ROBUSTNESS PRELIMINARY EXECUTIVE SUMMARY REPORT BRIGHTON AND HOVE CITY COUNCIL**

June 2024

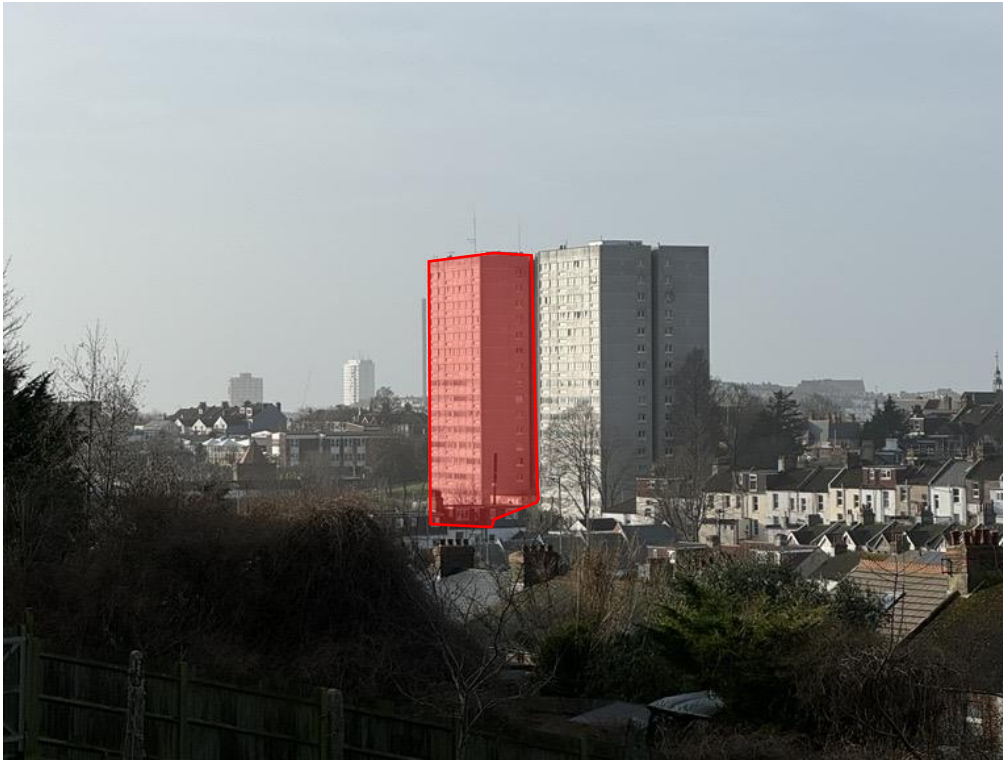
*Figure 1: Image of Upper Hollingdean Road Site indicating Nettleton Court*

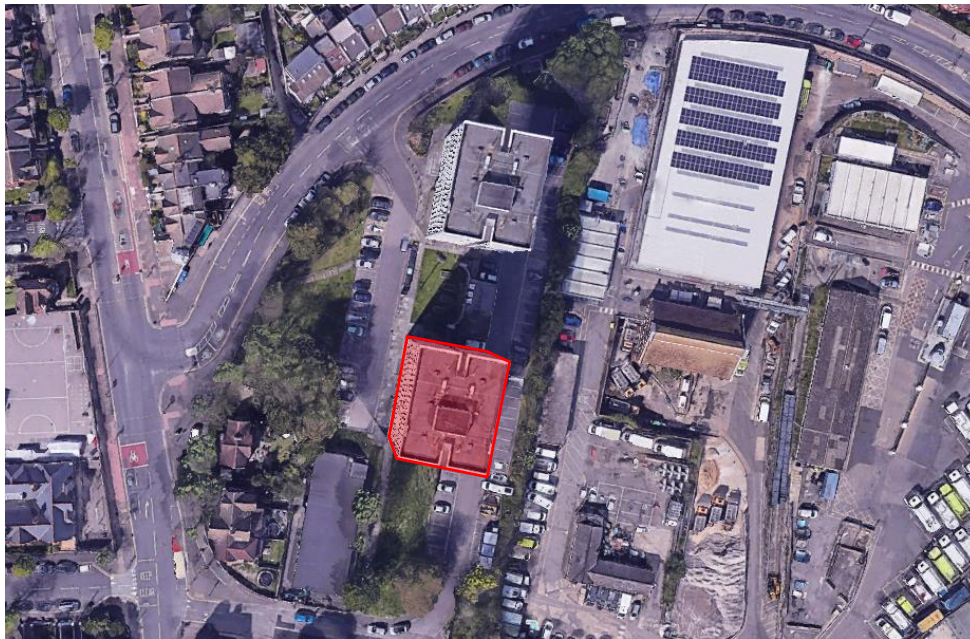
Figure 3: Nettleton Court (Google Earth, 2024)

The site is steeply sloped from west to east, with approximately 1 storey (3m) difference in external levels each side of the building. To the east side, the lower ground floor level comprises private garages.
