**HERON COURT
SWANBOROUGH PLACE
BRIGHTON & HOVE
BRIGHTON BN2 5QA**

**STRUCTURAL ROBUSTNESS
PRELIMINARY EXECUTIVE
SUMMARY REPORT**

JUNE 2024

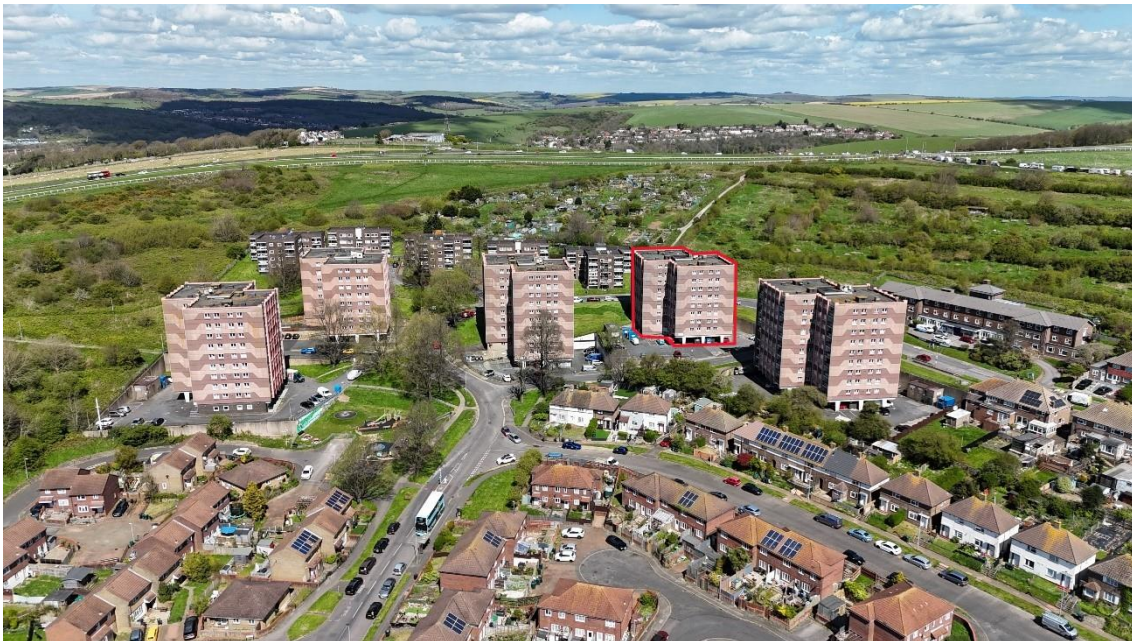
Figure 1: Aerial Image of North Whitehawk Buildings Indicating Heron Court Location

Above the reinforced concrete podium, the construction of the remaining eight upper floor levels comprises of Large Panel System (LPS) construction, consisting of precast floor and wall panels. The internal core, containing two lift shafts, stairs and risers is also constructed of a precast panel construction. All the buildings within the Whitehawk Estate are estimated to have been constructed circa 1965 and are believed to be of Wates LPS design.

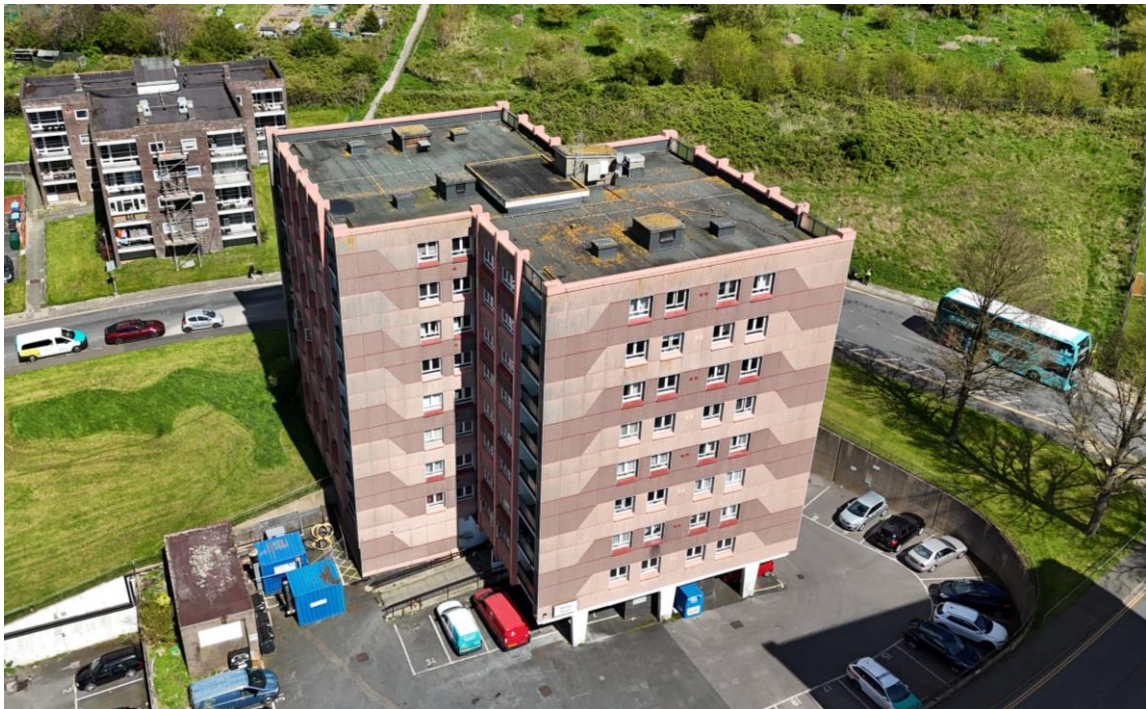
Figure 3: Aerial Image of Heron Court

The wider site is relatively steeply sloped; however, the local site upon which the building is situated has been levelled to create a private parking area. To accommodate this, a retaining wall parallel to three elevations to approximately the southern section of the building has been constructed, returning into the east and west elevations, connecting to the building structure, with the ground to the northern retained at approximately first-floor level.

By review of British Geological Society mapping data, it is understood that the site is underlain by Seaford Chalk Formation, comprising of Chalk. It is anticipated, given the bearing strata, construction, and form that the structure will be supported on piled foundations.
