**FALCON COURT
SWANBOROUGH PLACE
BRIGHTON & HOVE
BRIGHTON BN2 5QB**

**STRUCTURAL ROBUSTNESS
PRELIMINARY EXECUTIVE
SUMMARY REPORT**

JUNE 2024

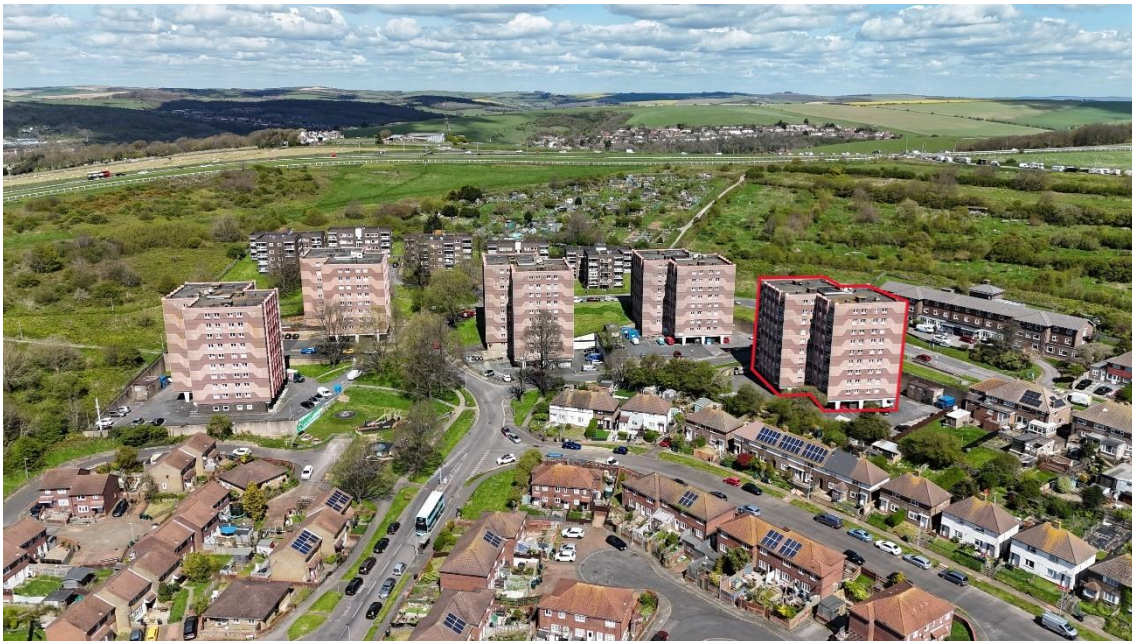
Figure 1: Aerial Image of North Whitehawk Buildings Indicating Falcon Court Location

Above the reinforced concrete podium, the construction of the remaining nine upper floor levels comprises of Large Panel System (LPS) construction, consisting of precast floor and wall panels. The internal core, containing two lift shafts, stairs and risers is also constructed of a precast panel construction. All the buildings within the Whitehawk Estate are estimated to have been constructed circa 1965 and are believed to be of Wates LPS design.
