# Stanmer Conservation Area

## Appraisal

**Designated: 1970**

**Extended: 1988 and 2010**

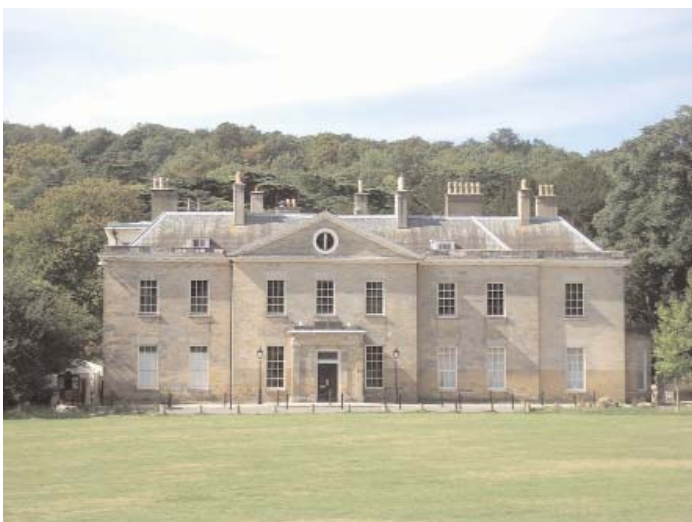
Figure 3: Stanmer House, East Facade

Listed at grade I, Stanmer House (Figure 3) dates primarily to 1722-7, although it is likely to incorporate parts of an earlier house. It was designed by Nicholas Dubois for Henry Pelham, with the designs completed for Thomas Pelham, after his brother's death. An enclosed porch with Tuscan pilasters was added in the early 19th century, and the main façade extended to the north in 1860. It is brick-built, with local Lindfield sandstone ashlar fronts to the main east and south elevations, and render to the remainder. Of two storeys with attic, it has hipped slate roofs. On the main east facade, the central three bays project forward and are capped by a pediment housing an oculus window. The roofline incorporates a number of prominent chimney stacks.

Although the focus of the park, Stanmer House occupies a relatively secluded location, nestled at the base of the valley, and not visible from much of the park. When approaching from the south for example, it only becomes visible abruptly at the left-hand turn at the top of the drive. This effect has been over-emphasised by recent planting, which has obscured the original more open aspect between the House and much of the park. The restrained classical style of the House contrasts sharply with the picturesque vernacular style applied to the village. With the Great Wood as a backdrop to the House, its formal architecture is also juxtaposed directly with the surrounding 'natural' landscape and vegetation.

The House originally comprised four wings, of which two have now been demolished, and replaced by temporary car parking. The fencing and lighting in this area is modern, and unsympathetic to the historic character of the park. The rear area contains a 17th century gin wheel and a number of remnants of flint walls and buildings, which add historic and architectural interest. The rear aspect of the House presents an irregular roofline, which may provide subtle evidence for the pre-18th century house.

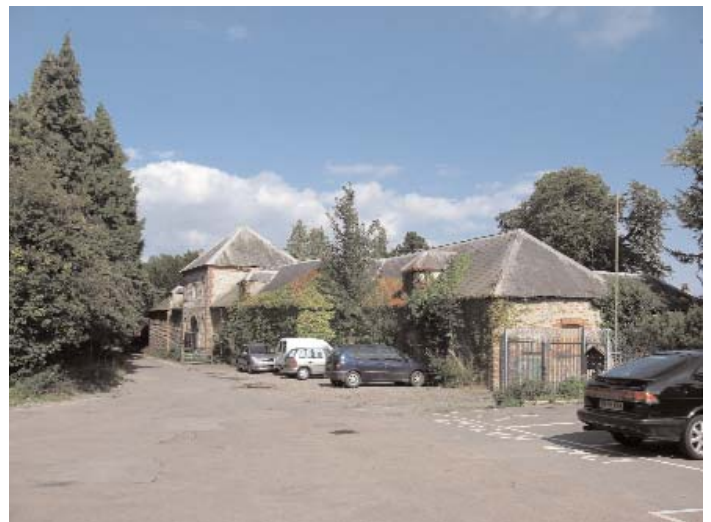
Figure 4: Stables

The prestigious stable block was constructed in 1778 (Figure 4). It has coursed flint and red brick walls to the exterior, gault brick walls to the internal courtyard elevations and hipped slate roofs. It is U-shaped, with a central carriageway entrance along its north side housed beneath a squat tower. On this side, the stables form a hard edge to the road. This, alongside mature vegetation, encloses views in the area. Empty and dilapidated, the future of the building is uncertain. Its current condition erodes the character of the area.

The open side of the courtyard orientates towards Stanmer House, with the two buildings relating directly to one another. However, surrounding vegetation is designed and located so that the stable block is not visible in views of the House or from the gardens.

- The stable block is empty and dilapidated. The condition of the building will continue to deteriorate unless works are undertaken to consolidate the building and a suitable new use found

- (i) Negotiate a new use for Stanmer Stables and secure emergency repairs to preserve the fabric of the building
- (ii) Improve the public realm in the ancillary area
- (iii) Improve the area of the cedar lawn including opening up views out of the area.

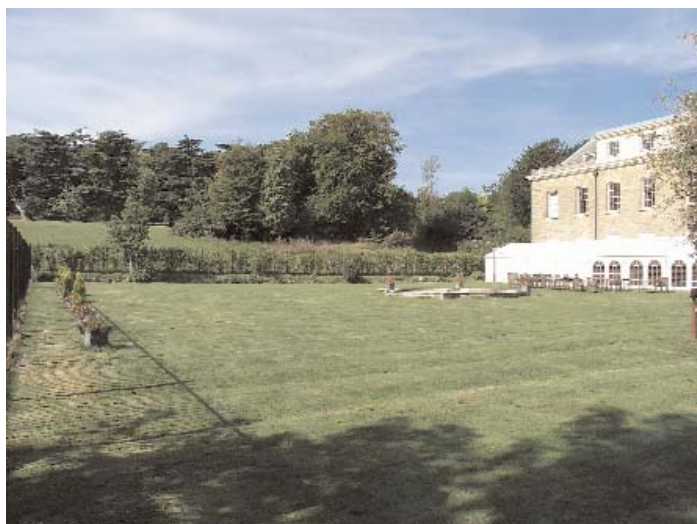
Figure 5: Fountain Garden

A formal square lawn (Figure 5), containing a central fountain, fronts the south elevation to Stanmer House. It was first levelled in the early 18th century, possibly as a bowls green, and the fountain was present by 1875. The use of the garden for events associated with the House has led to some modern intervention, including the erection of a tall fence to the south. The levelled area extends to the south, to a further lawn, bordered on three sides by vegetation, and with a steep 20th century earthwork to the west, which is of little historic character. This area retains a character somewhere between the formal space of the fountain garden and the more informal character of the rest of the park. It is accessed via a 20th century decorative iron gate.

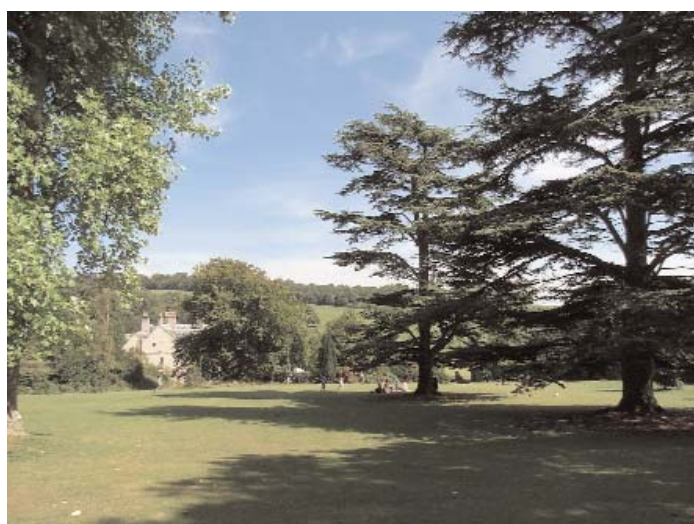
Figure 6: Cedar Lawn, looking to House

The cedar lawn (Figure 6) comprises a gently sloping grassed area with a number of large and particularly majestic cedar trees. The size, shape and colour of these trees are distinctive, and they are visible from many areas across the park. The area is bounded by belts of vegetation, which limit views out of the area, and create a sense of seclusion. This is overemphasised by 20th century vegetation to the south, including a cherry tree orchard and dense hedge. These have a harmful effect on the originally more open aspect between the House and parkland to the south. A vacant glasshouse beside the walled garden and a ruined orangery building (built in the 1970s based on historic precedent) identify the presence of, and provide access to, the ancillary area to the north. However, their neglected state has a negative impact on the area, and the access routes are not immediately apparent. The cedar lawn is bounded by woodland to the west, which contains remnants of flint walls and the pet cemetery; further clues to the historic nature of the area. In some areas the flint walls require stabilising and repair in order to halt further decay.

- The orangery and glasshouse are in disrepair and detract from the character of the cedar lawn
- Areas of flint walling are in disrepair or have been replaced with poor quality fencing

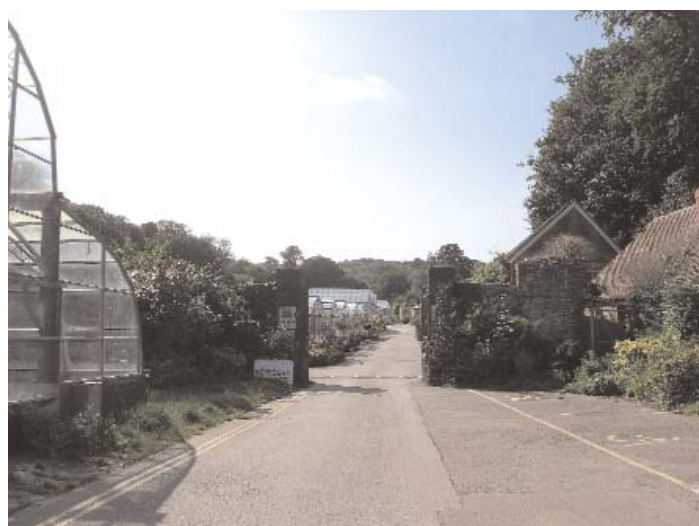
*Figure 7: Entrance to Walled Garden*

The area of hardstanding is used informally for parking, and requires maintenance. The entrance to the walled garden provides a focus to the area, comprising tall brick piers and an iron gate (Figure 7). It is flanked by a glasshouse to the south (and pedestrian access to the cedar lawn), and a 19th century grade II listed store shed of brick, flint and weatherboarding to the north.

- The area of hardstanding outside the Rural Museum and entrance to the walled garden requires maintenance
- The City College buildings obscure the previously open aspect to the north of the stables. The character of the College is pleasant, but has no historic precedent

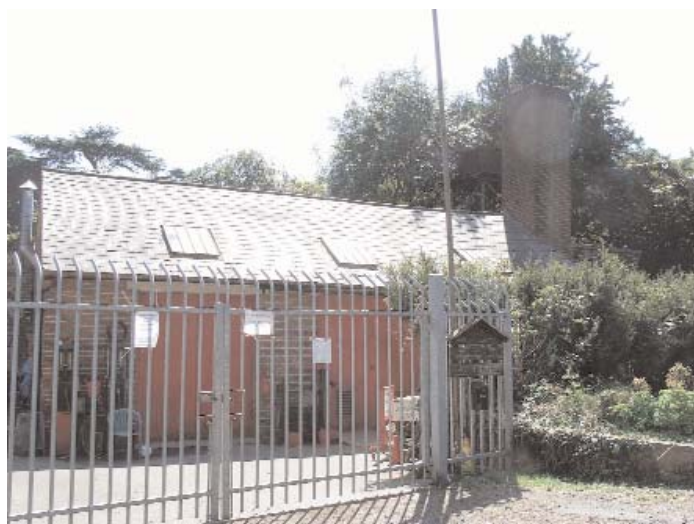
*Figure 8: Stanmer Rural Museum*

There has been a building in the location of the Rural Museum (Figure 8) since at least the 1840s, but the current building appears mostly 20th century in date, with brick walls, concrete lintels to large openings, a pitched slate roof and brick chimney. The building is set behind a poor modern gate and tall hedge.

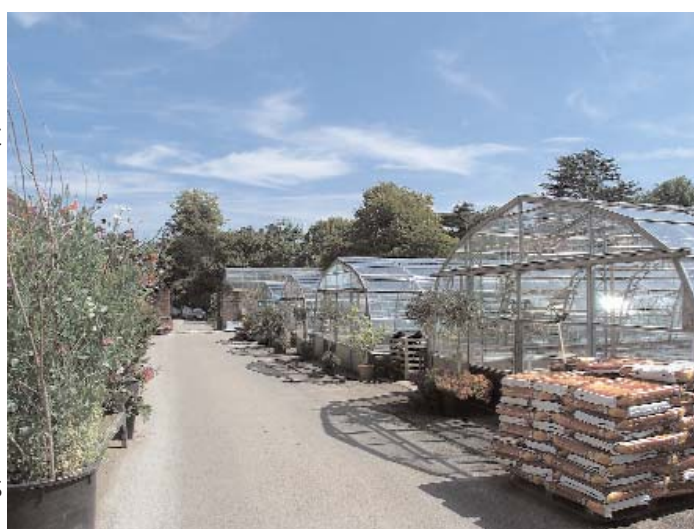
*Figure 9: Walled Garden*

The flint and brick walls of the 18th century walled garden to Stanmer House survive largely intact and act as a reminder of the historic nature of the area. The walls are approximately 2.5 metres high and built in red brick and flint, with numerous areas of rebuilding and alteration. The entrance forms a dominant feature, and is set to the north of the east wall. It comprises two rebuilt brick piers with a projecting course to the top, supporting a large iron gate. The walled garden is used as a nursery (Figure 9), and contains a series of north-south aligned glasshouses, polytunnels and storage areas, displaying varying levels of use and maintenance. Although these structures are modern in character, its continued use for horticulture is in-keeping. The tall wall acts to enclose the area, promoting a sense of detachment from the rest of the park.

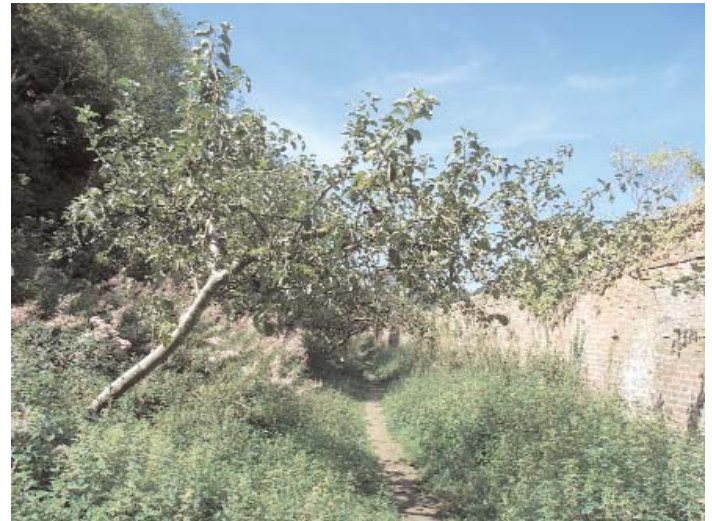
*Figure 11: Orchard*

The orchard lining the south wall of the walled garden (Figure 11), and the Care Co-operative Farm to the west, are depicted in the Figg Plan as under horticultural use. The current uses of these areas are therefore in-keeping with their historic use. They form pleasant green, secluded spaces. The south wall of the walled garden is a dominant feature in views in the orchard and, combined with the woodland to the south, promotes an extremely high sense of seclusion in the area. A flint wall is present to the rear of the Care Co-op Farm and orchard.

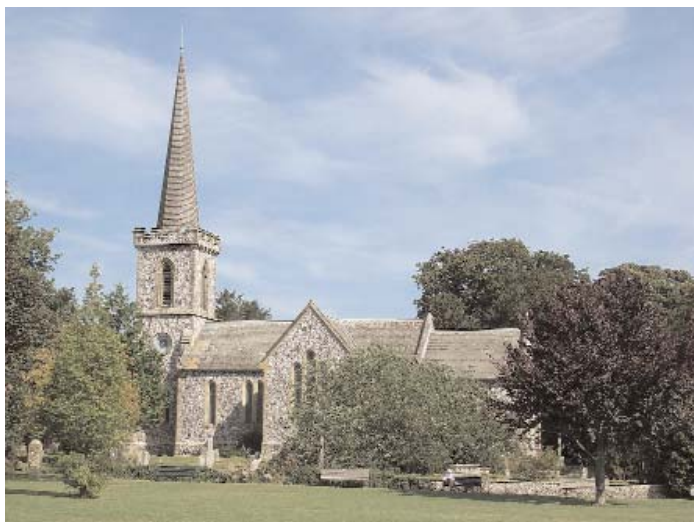
*Figure 12: Stanmer Church*

Built in 1838 in the Early English Style, the church is highly picturesque, with galletted flint walls, stone dressings and an elegant shingle spire (Figure 12). Redundant as a place of worship, its future use is uncertain. It is situated in a small graveyard with flint boundary wall and railing. A ha-ha to the south links this green space directly to the park. An ancient yew to the north of the church emphasises the antiquity of the area. The village well and donkey wheel are located in a small flint structure to the north of the graveyard. Contemporary with the present church, it reuses fabric from the former church. The church is a major landmark, with the spire visible from much of the park, across the adjacent pond and as the south terminus of the village street.

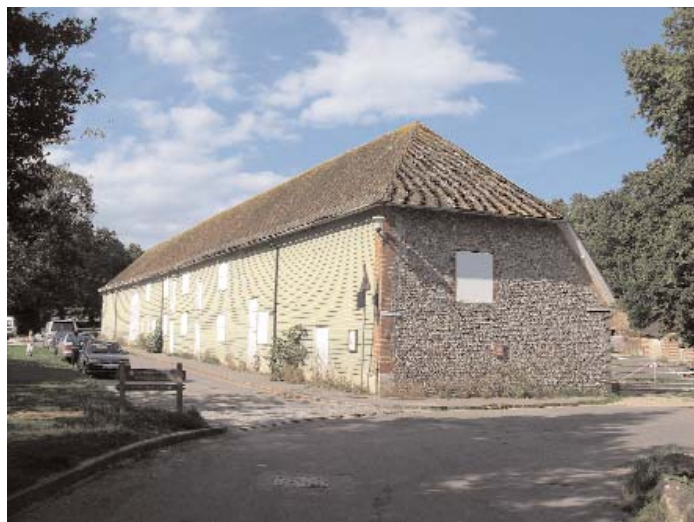
*Figure 13: Village Barn, Home Farm*

Home Farm constitutes the south half of the village. The farmhouse is set in a large plot with flint boundary wall and orchard to the rear, and with flint and brick walls and a slate roof. Its size and materials promote a level of prestige, relative to the other dwellings in the village. The long, double-height barn is the most visually striking building, fronting directly on to the east side of the street (Figure 13). It is flint-built with red brick dressings, and weatherboarding to its street frontage.

A range of pitched-roofed farm buildings, stores and covered stalls bound the area into a series of yards. Although the fabric of these structures is not all historic, their scale, massing and materials are significant. Above all, the arrangement of buildings to enclose and form open yards is of particular importance to the character of the area. Contained views are apparent across the yards to the open parkland beyond.

The farm buildings are currently vacant and require a new use to ensure their future. In order to maintain their character, and that of the village, residential conversion is unlikely to be appropriate.

- The recent closure of Home Farm means that there are now a significant number of historic buildings (including the grade II listed Barn) with an uncertain future. Some of the buildings are already in need of some repair.
- Some areas of pavement and the hardstanding beside the toilet block in particular are poorly maintained, and currently detract from the historic character of the village.
- Ivy, although relatively picturesque, is in some areas enveloping buildings, including farm buildings and number 3 Stanmer Park. Ivy can be very damaging to buildings, and requires pro-active management and/or removal.
- Parked cars - particularly on the pavement - impact on views along the village street, detracting from its historic character.

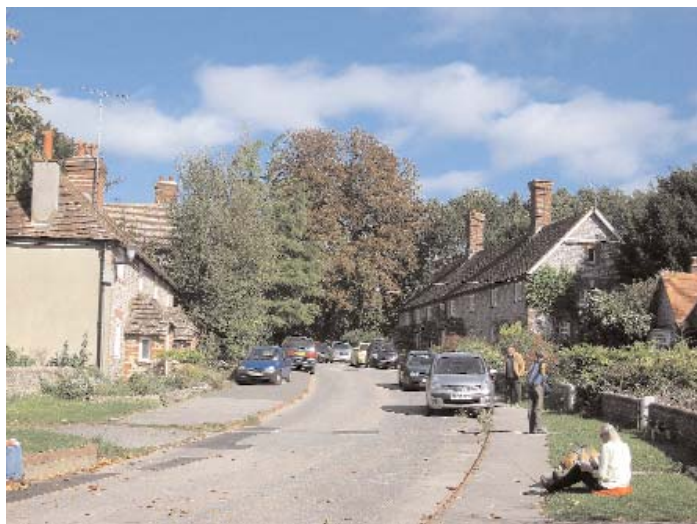
Figure 14: Cottages, Stanmer Village

The north half of the village comprises small-scale residential dwellings (Figure 14). Built over the 18th and 19th centuries, they display uniformity in scale and materials, including:

- two storey height,
- pitched or hipped clay tile roofs,
- flint walls with brick dressings,
- timber horizontal sliding sash windows,
- prominent decorative brick chimney stacks, and
- low flint boundary walls with half-round brick coping and white picket gates.

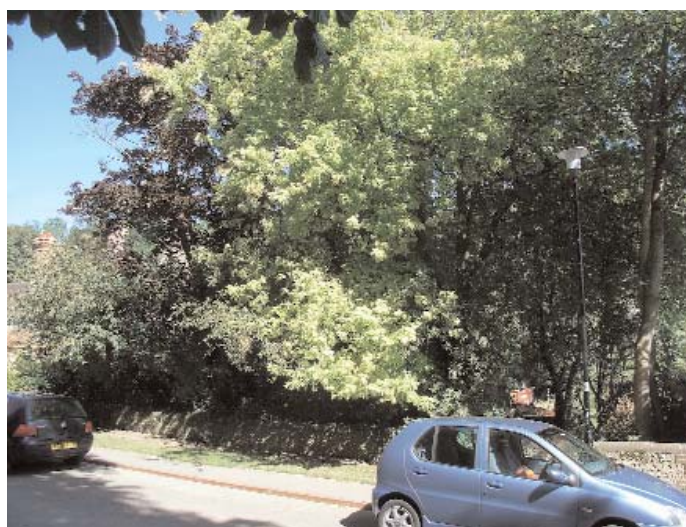
Figure 15: Vacant site

The former housing plot between numbers 16 and 19 is now vacant; presenting a belt of vegetation to the streetfront (Figure 15), and being used unofficially as residents' parking. This site could provide the opportunity for a new small-scale housing development, in order to clarify and re-establish the original continuity of built form along the street. However the use of the site for parking reduces pressure for on street parking. Any development proposal would need to contain careful consideration of parking provision and also of the archaeological potential of the site.

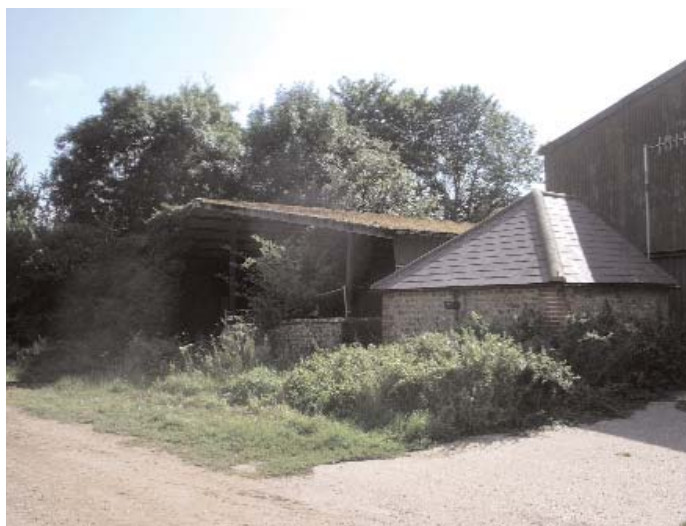
*Figure 16: Flint-walled farm building*

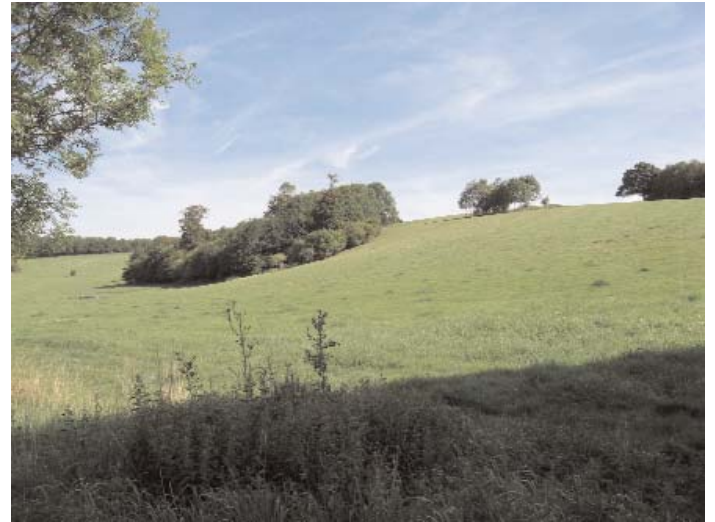
*Figure 18: Access Land*

The access land (Figure 18) lies mostly to the east of the drive. Recent removal of fences means the whole area is now open as one, with numerous gated access points. The area forms open cattle grazing, interspersed with clumps of trees of varying size and shape. These clumps do not exactly correlate to those shown on the Figg plan, but nevertheless work in harmony with the designed landscape to frame and channel particular views. The access land is bordered to the east by fenced woodland, which runs along the ridgeline. Extensive views are afforded from a gap in this woodland, particularly to the south frontage of Stanmer House, the church spire, across the park more generally and over the developments and downs to the south.

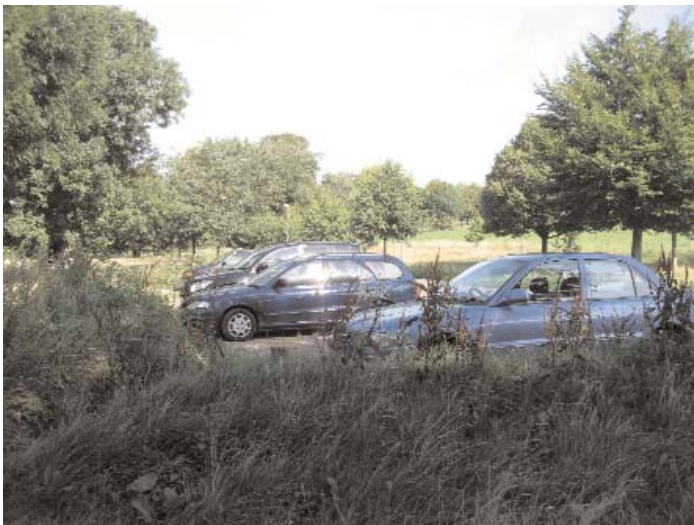
*Figure 21: Parking along drive*

- (iv) A coherent strategy should be formulated for paraphernalia in the park, and along the drive in particular. Signs, surface markings and other modern interventions should be kept to a minimum and, where they are necessary, located sensitively. In general, well-placed and well-designed surface markings would be more appropriate than signs to control speed. Traffic calming measures would introduce a more urban character to the area, so should be avoided wherever possible. If found necessary, they should be as sympathetic as possible to the historic character of the area. Double yellow lines would generally be inappropriate in the park. Tarmacadam should be replaced where possible with gravels.

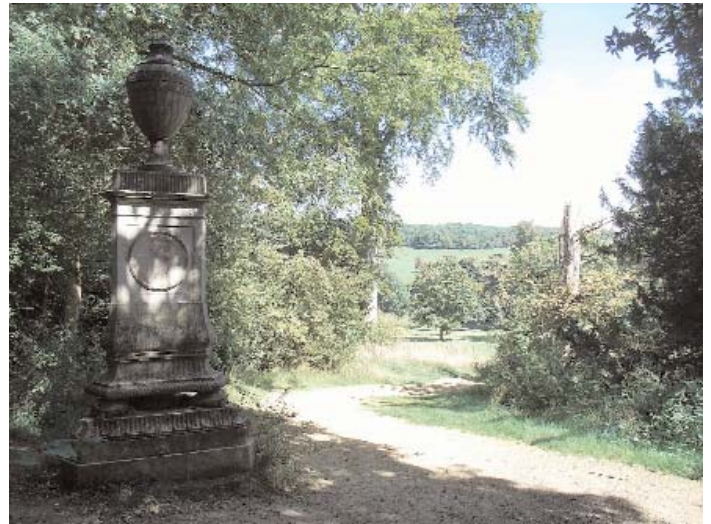
*Figure 22: Frankland Monument*

Located in the Forest Garden, the monument was built in 1775 and dedicated to Frederick Frankland (Figure 22). Triangular in plan and classical in style, it is built in coade stone, with a large base with latin inscription, above which a funerary urn surmounts a column resting on three tortoises. The monument is largely hidden in views within the park. Its unexpected discovery when walking through the woodland acts as a reminder of the historic nature of the area.
